Fukushima Nuclear Disaster

January 18, 2012

Congressional Research Service
7-....
www.crs.gov
R41694

CRS Report for Congress
Prepared for Members and Committees of Congress

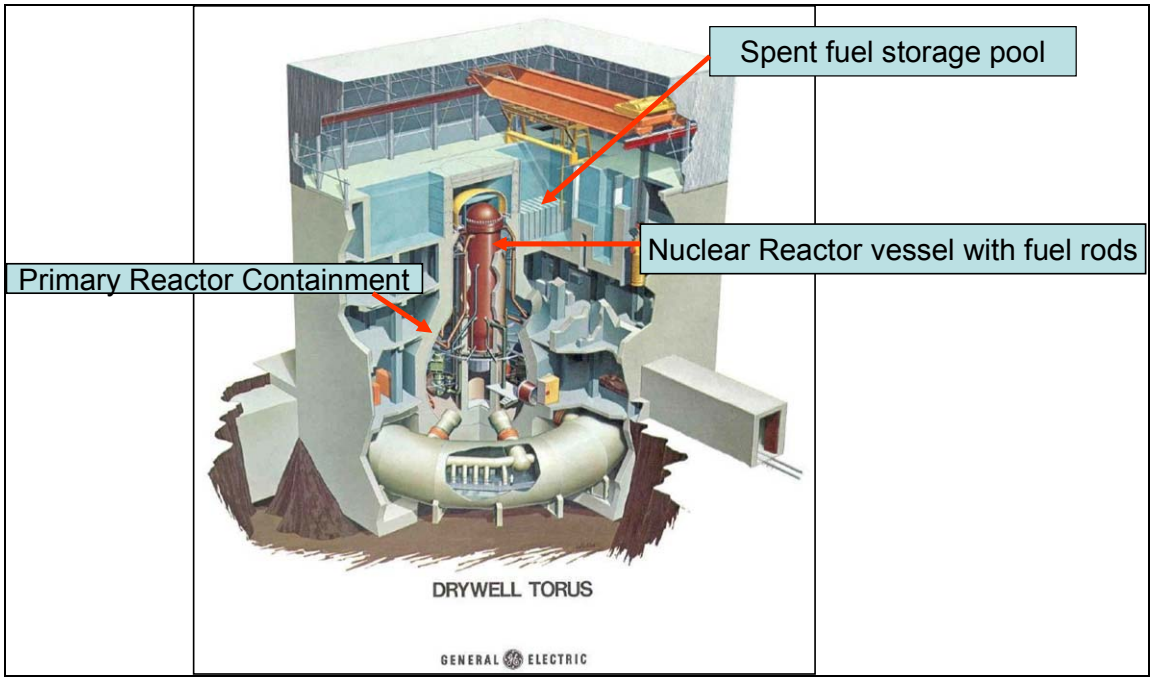
Figure 2. General Electric Mark I Boiling Water Reactor and Containment Building

The loss of cooling also affected the plant's spent fuel pools (shown in **Figure 2**), which hold fuel rods that have been removed from the reactors after their ability to sustain a nuclear chain reaction has diminished. Although much of the radioactivity in the spent fuel has been decaying for many years, the large volumes of spent fuel in the pools represent a significant total heat load. If water in the spent fuel pools boils away or leaks out, the spent fuel rods may overheat and release radioactive material into the air. Because of concern that water in the Fukushima Daiichi spent fuel pools may have been splashed out or leaked during the earthquake and begun boiling away after cooling systems were lost, dramatic efforts were made to spray water into the pools or drop water from helicopters. Later analysis indicated that the pools did retain sufficient cooling water during the accident.[19] However, the explosions of reactor buildings 1, 3, and 4 exposed those pools to the atmosphere, and debris from the explosions may have fallen into the pools and damaged the stored fuel.

On March 15, while workers were attempting to vent the Unit 2 containment, they heard a loud noise near the torus (see **Figure 2**) followed by a reduction in containment pressure. The sound was later determined not to have been an explosion as initially suspected, but it may have been associated with a breach of the primary containment. Meanwhile, the rupture of a large, rectangular blowout panel in the outer wall of Unit 2 apparently allowed hydrogen to escape from the reactor building, preventing the explosions that occurred in the adjacent units.[26]

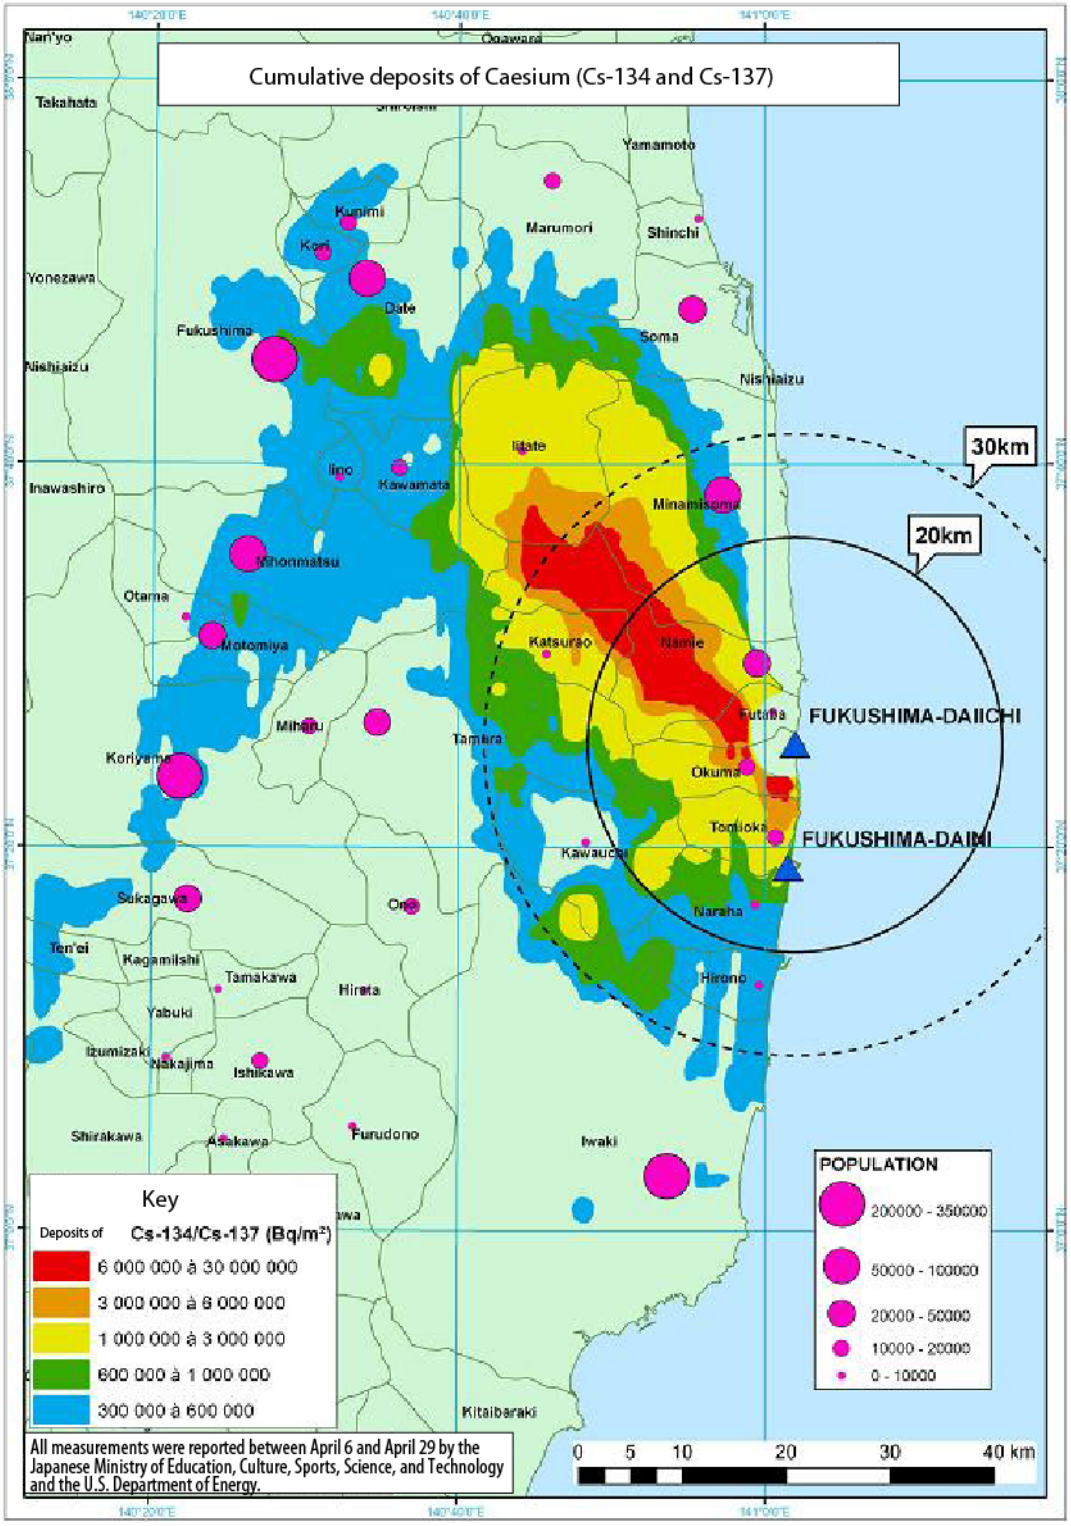
Figure 3. Cesium Depositions Around Fukushima-Daiichi

Contamination of the land around the Fukushima plant was concentrated to the northwest, leaving large areas uninhabitable, as shown in **Figure 3**. Most of that contamination occurred when prevailing winds that had been carrying the plant's atmospheric releases over the Pacific Ocean shifted to the northwest during two days in mid-March and heavy rains washed the radioactive material from the air.[40] The depositions of radioactive cesium (the primary long-term land contaminant) are "comparable with the most contaminated areas of Chernobyl, even beyond the initial 20 km-radius evacuation zone around the Fukushima plant," according to the French Institut de Radioprotection et de Surete Nucleaire (IRSN). However, the amount of land around Fukushima with cesium deposits greater than 600,000 becquerels (16.2 microcuries) per square meter was estimated to be "only 8.5% of that of Chernobyl."[41]
